Manhole Inspection Summary

Manhole # S53K__038MH

Location Address: **rear 3234 fait ave**

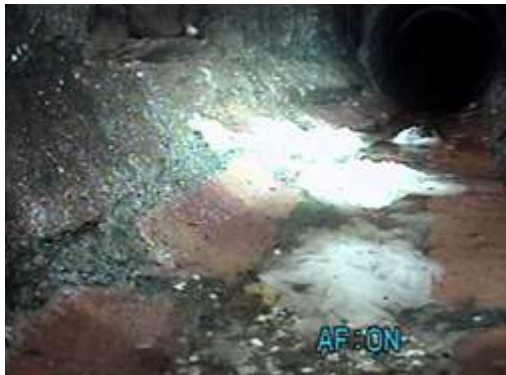
Misc.

channel debris

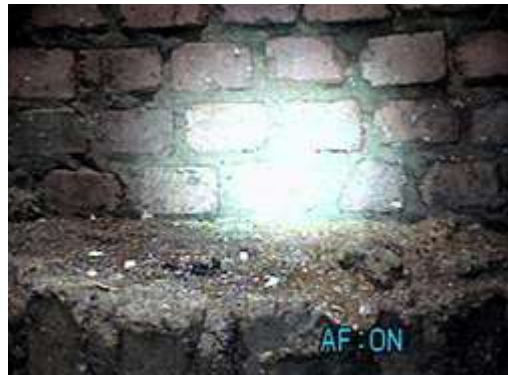
Misc.

bench debris

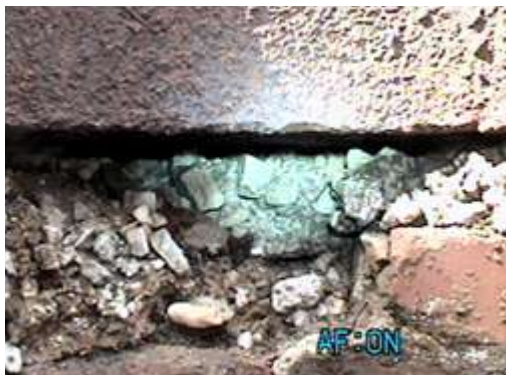
Defect 3

Condition: ☐ Sound ☐ Cracked ☐ Root Intrusion ☒ Loose Brick ☒ Deteriorated

frame adj loose bricks, deteriorated

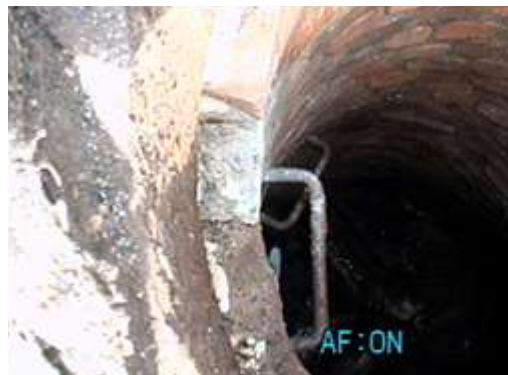
Defect 2

Frame Offset: **2** (in.) Condition: ☒ Sound ☐ Cracked ☐ Leaks

offset

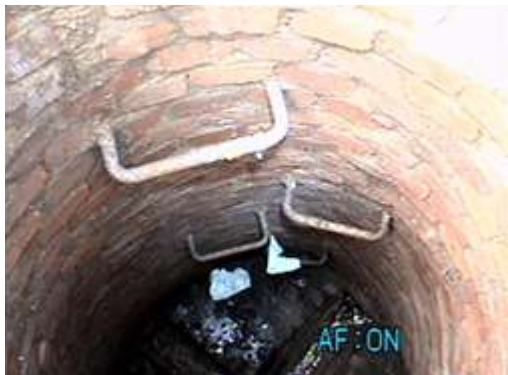
Defect 1

Steps Count: **4** Missing: **0** ☒ Corroded

cor.steps (no evidence of surcharge--the paper came from above)

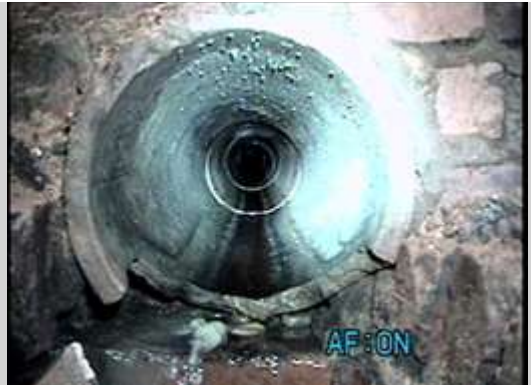
9 O'Clock Inflow

bottom of pipe is broken
